New Zealand Fire Service National Headquarters

Operational Review Report

47 VICTORIA STREET
RANGIORA

Incident Date: 20/09/2009 9:17:42 PM

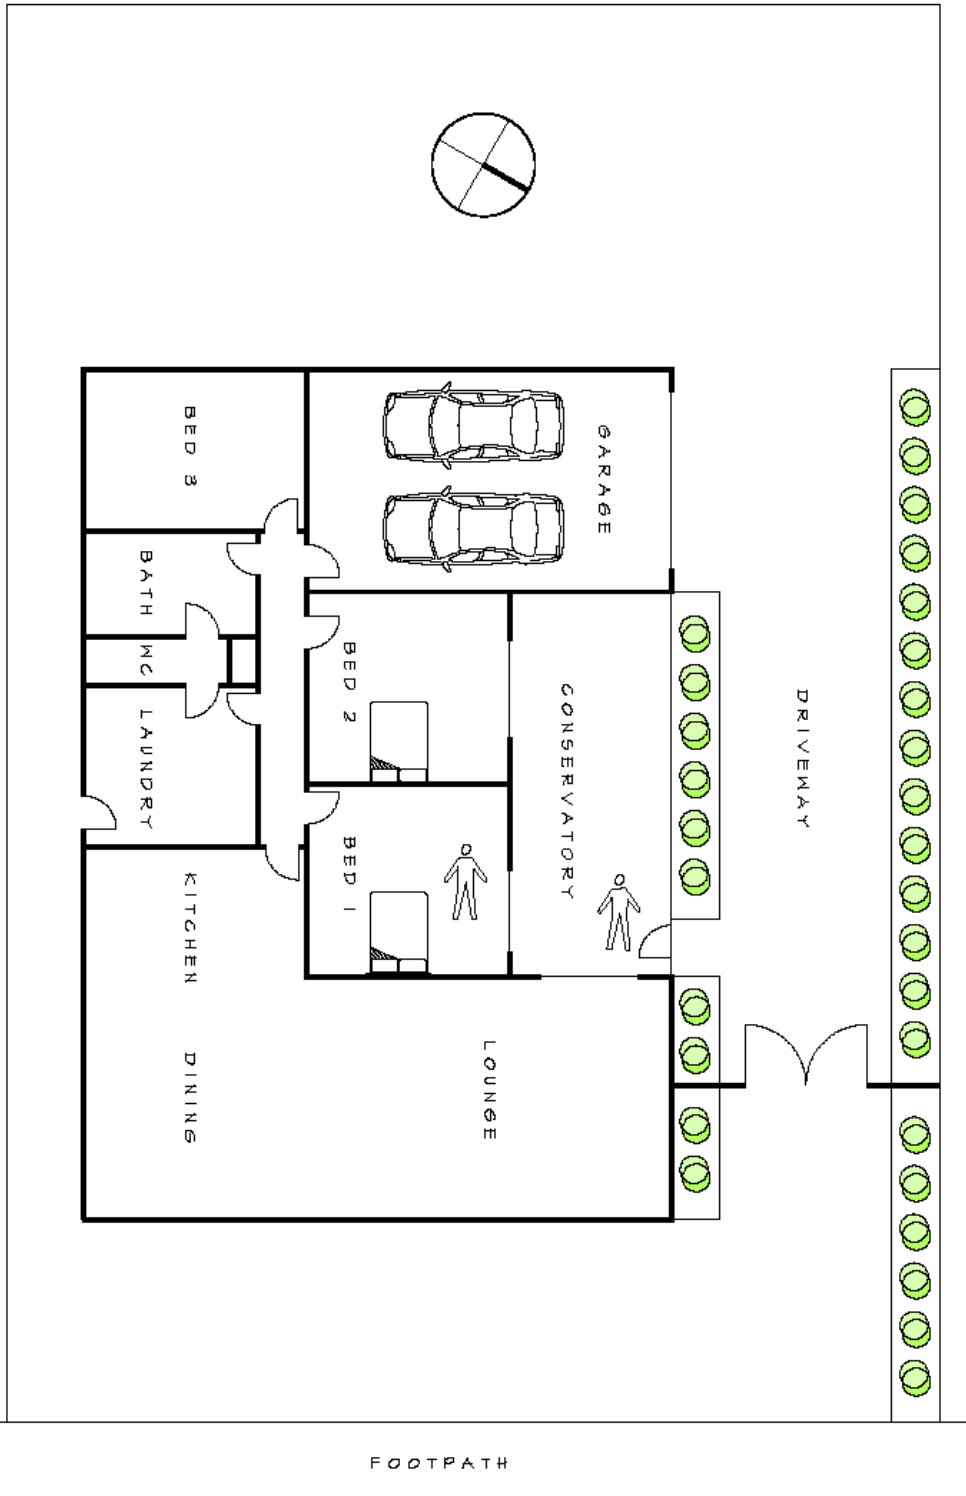
Appendix 1: (Not to scale)

- At some time in its past, the house had had a conservatory built on and this now contained the front (sliding) door. On arrival of the first Rangiora appliance, the fire had vented from the bedroom (bedroom 2) into the conservatory area, this was the shortest route into the lounge, where the missing woman was reported. To protect the initial search team, this area needed to be kept free from fire development.

1. The point of origin of the fire was the electric blanket and attempts by the occupants to extinguish the fire as well as leaving the bedroom door open contributed to the spread of fire

2. Had the door from the room of origin (bedroom 2) been closed by the occupants the fire would not have spread so quickly and the occupants would have had a greater chance to escape
